The 2013 rockslide disaster of Aizawl, Mizoram, India

Laldinpuia^{1*}, Shiva Kumar² and T. N. Singh³

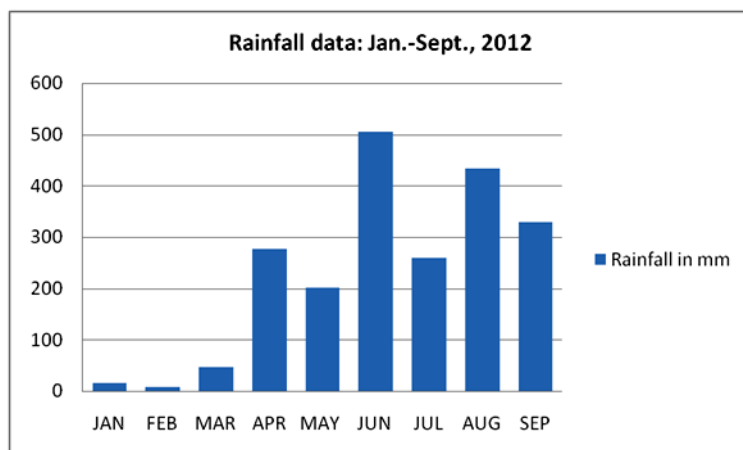
Figure 2. Rainfall data in Aizawl at the time the danger was noted.

City.¹ On September 2012, after heavy rainfalls of about 2064 mm (Table 1, Fig. 2), cracks were observed at the rock bed and soil, retaining walls and PWD RCC building which occurred at the crown along the Laipuitlang road. By the suggestion of geologists' from Geology and Mining Resources Department, Government of Mizoram, PWD building was vacated, and ordered to be demolished. But, before taking action, the rockslide destroyed the building, and observed as the factor that increased the catastrophic disaster for settlements at the toe region.

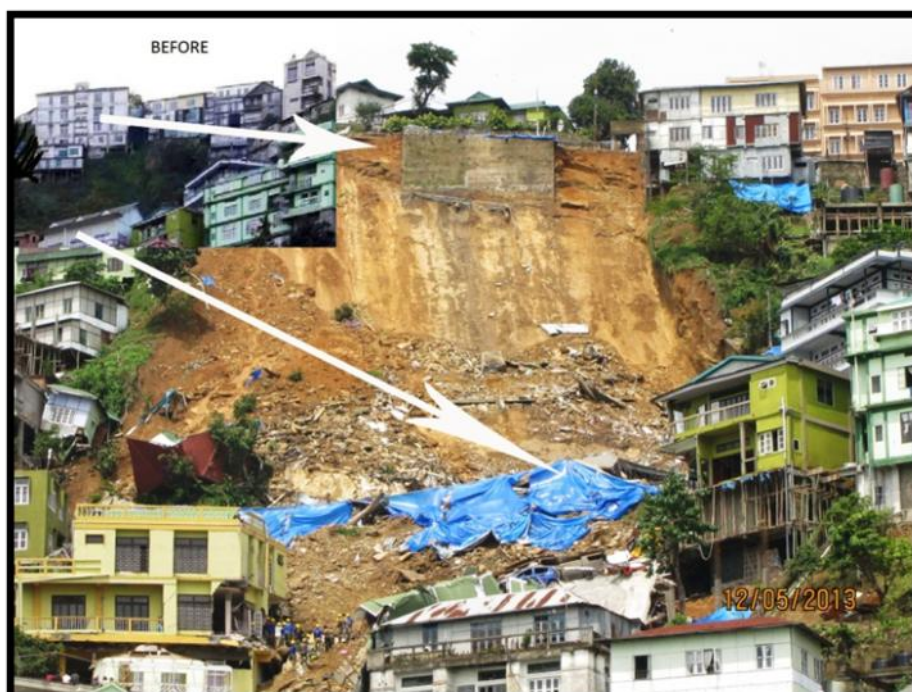
Figure 3. Laipuitlang Rockslide view from Ramhlun Venglai.

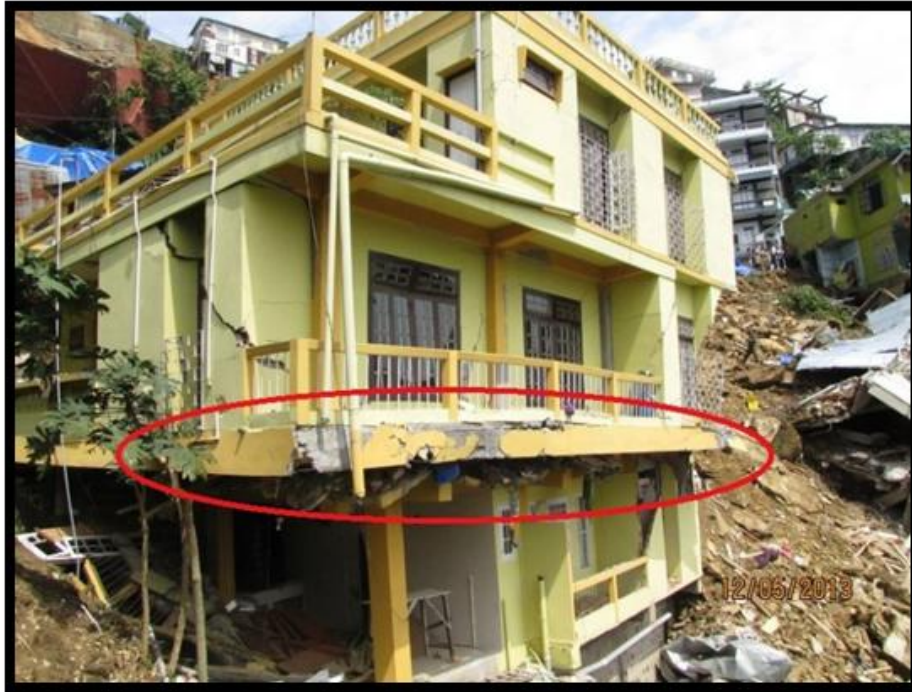
Figure 4. Marked line indicated one storey failure of the affected residential at the toe region.

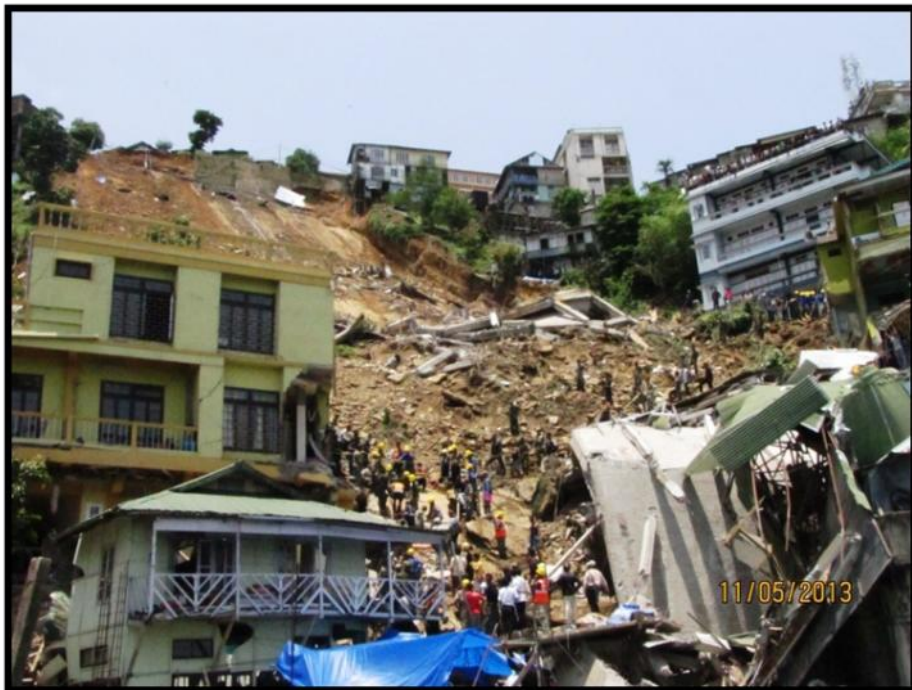
Figure 5. Action of State Disaster Search & Rescue Team at the rupture surface.

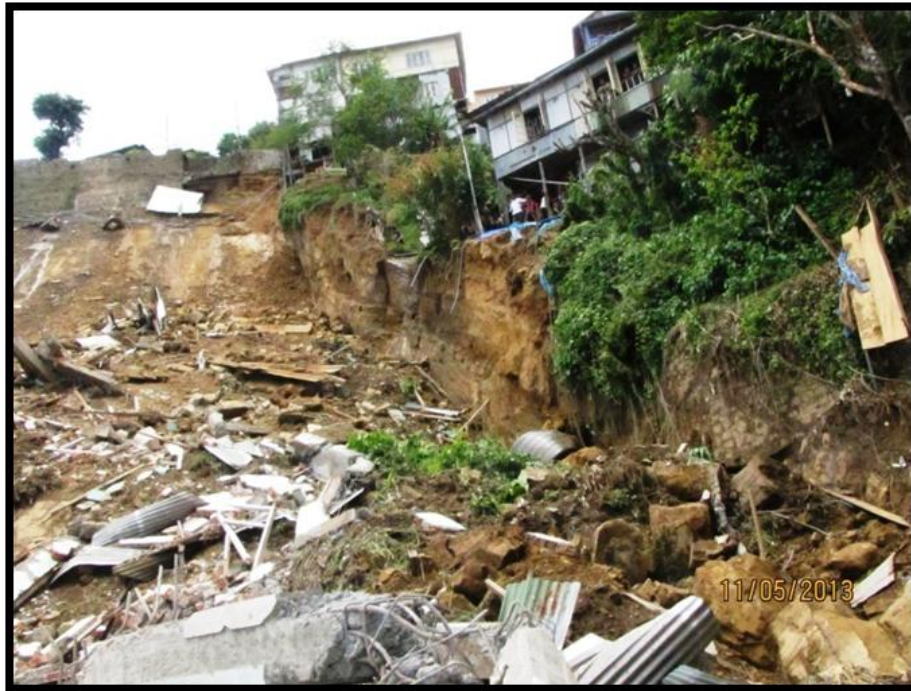
Figure 6. Photograph showing the rapture surface, crown and minor scraps.

The bedding of the rock was disturbed by water from the surrounding seepage and rainfall, and unsafe cutting at the southern side for building construction. A tension cracks are observed on the top of upper surface, and near the minor scarp, but not observed on the slope face (Fig. 6).

Laipuitlang rockslide is one of the worst disastrous rockslide after South Hlimen quarry rockslide that took place in 1992. This plane failure may be prevented when investigated the factors of rock instability. Rock bolt to be applied at rock bedding, decreasing the load of the crown and proper drainage systems are suggested for mitigation of in and around the affected area.
